WORLD WIDE JOURNAL OF  
MULTIDISCIPLINARY RESEARCH AND  
DEVELOPMENT

## Identifying the quantitative characteristics of the erosion processes provoked by fire on the mountain slopes surrounding the Naghvarevi stream in the Borjomi valley

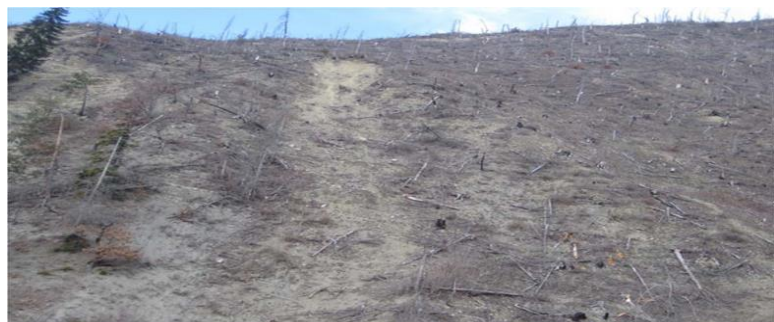
**Photo 1:** The initial stage of the erosion processes.

The current processes, in themselves, have contributed to increase of ecological risks, As a result, in the resort areas, the status of which mentioned above almost every region owns, the flow of tourists and vacationers decreased, which had a negative impact on the development of the infrastructure of this sector and, accordingly, on the economic indicators of the region. Based on the above, in order to assess the vulnerability of the slopes of the mountains burned in Borjomi valley, we carried out field-reconnaissance works during which particularly vulnerable areas were identified, namely, the right tributary of the Gujarula river, Naghvarevi stream (village near Daba), where active erosive processes provoked by fire were identified (Photo

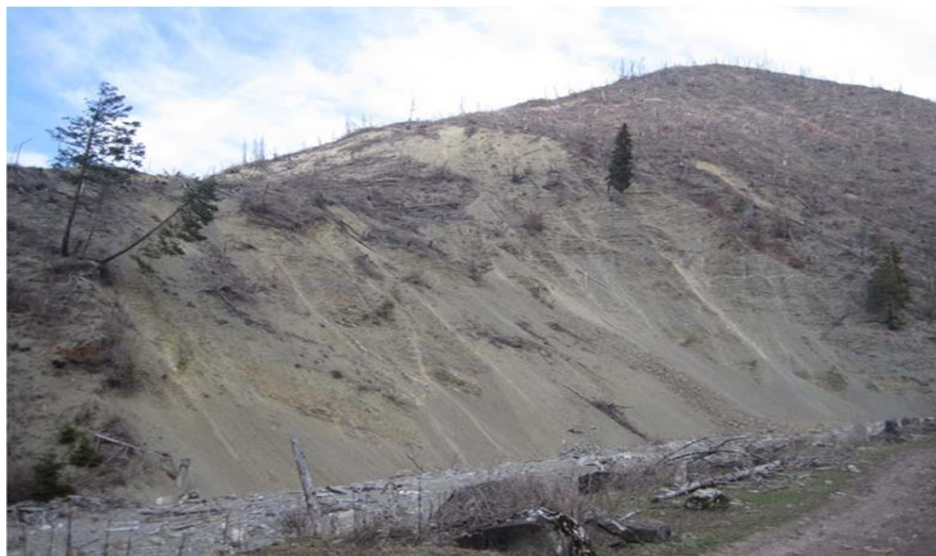
**Photo 2.** Active erosion processes.
